OFFICE OF EXPERIMENT STATIONS—BULLETIN 249, PART II.

THE STORAGE OF WATER FOR IRRIGATION PURPOSES—PART II.

TIMBER DAMS  
AND  
ROCK-FILL DAMS.

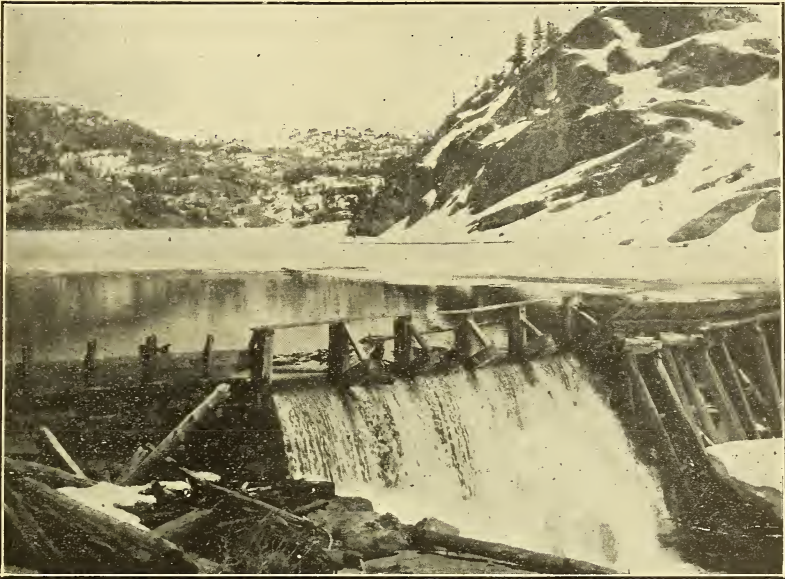
The surplus water from the reservoir flows over a spillway constructed at one end of the dam. This spillway (fig. 4) is 35 feet wide and 3 feet below the crest of the dam. It is equipped with flashboards, so that the water level of the reservoir may be varied at least 2 feet. The posts supporting the flashboards are 6 by 6 inches and spaced 7 feet centers. At times when the river is low the water is drawn from the reservoir by means of a "slum" gate, which is opened and closed by a threaded screw, at the top of which is a capstan nut operated by an iron bar. The gate slides on the upstream slope of the dam. The dam is in a bad state of repair, it being difficult to renew any part, owing to the decayed condition of the wood.

FIG. 4.—Spillway, Big Dam, South Fork Stanislaus River, Cal.

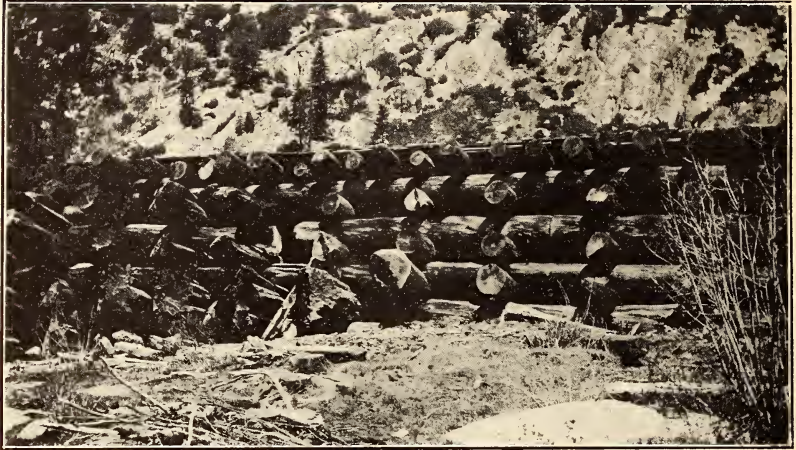
This dam is located 10 miles below Big Dam on the same river. Its structure is the same as Big Dam, being of the continuous crib type. (Fig. 5.) The dam was originally 650 feet long, but about 300 feet was abandoned and in its place a small earth-fill dam was constructed. The portion of the cribwork remaining was retimbered where it had become rotted and two thicknesses of 2 by 12 inch planking were placed on the upper slope. (Pl. III, fig. 1.) The abandoned portion of the dam and the manner in which the logs were placed are shown in figure 6. In the fall of 1907 a new apron was placed in the wasteway, the old apron having rotted out. (Pl. III, fig. 2.) The floor of the apron was built of 4 by 12 inch planks and the uprights are 4 by 6 inch, against which flashboards are placed to vary the water level of the lake. The manner of placing the logs

FIG. 5.—Middle Dam, South Fork Stanislaus River, Cal., showing manner of laying logs from the reservoir site. The site was not thoroughly cleared, however, only the best timber suitable for the construction of the dam being used. This standing timber is rotting at the water's edge and

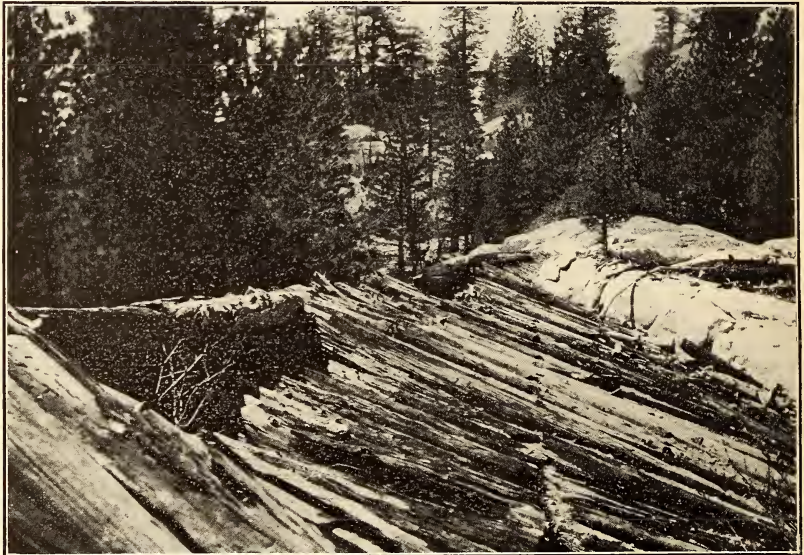
in the cribs and the notching of one on another has been shown in figure 6. The timber used in the construction of this dam was taken

FIG. 6.—Abandoned portion of Middle Dam, illustrating the placing of logs on upstream slope of continuous-crib dams.

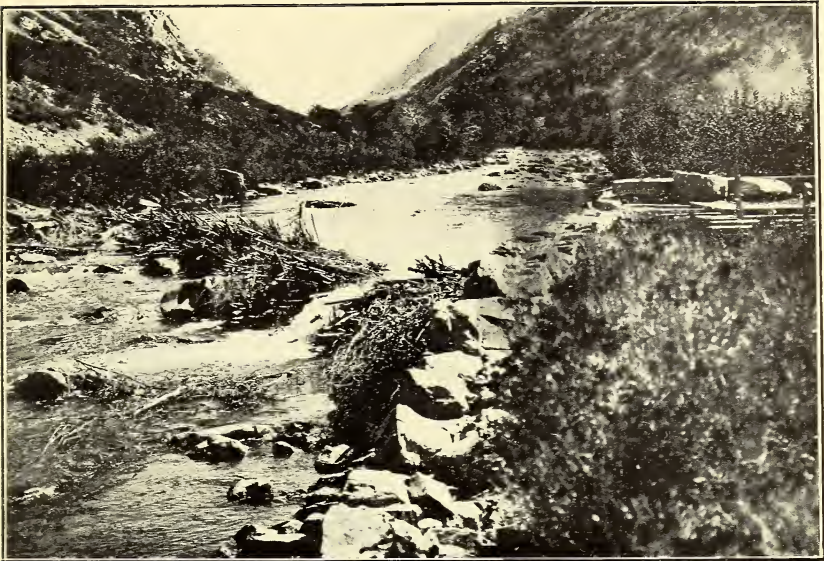
FIG. 1.—BRUSH DAM, WEBER RIVER, UTAH.

From the use of a small mat, weighted with rock, placed in creeks and small streams, the practice grew to include the damming up of some fairly large rivers for diversion purposes. A brush dam of the old type is shown in Plate I, figure 1. For 20 years or more this cheap weir and its predecessors, that were carried by floods into Great Salt Lake, served to divert water from Weber River, Utah, into the Davis and Weber Counties Canal.

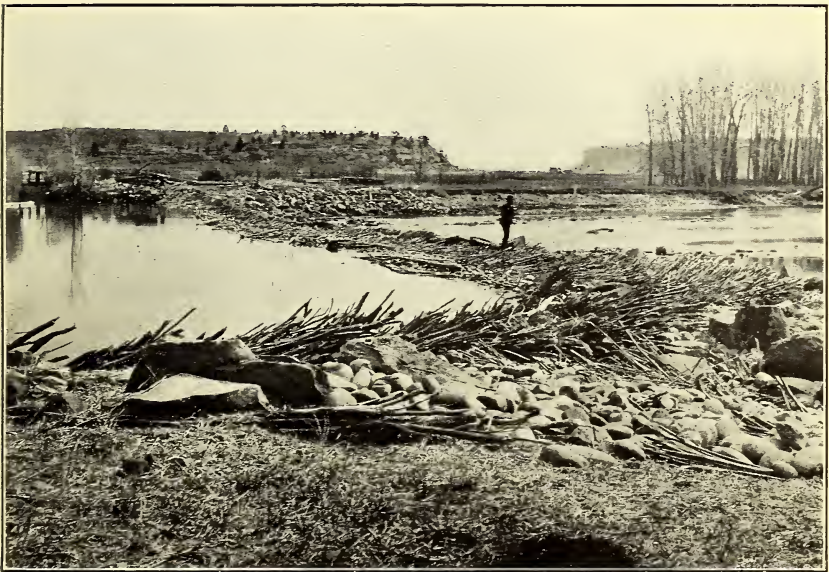
FIG. 2.—A BRUSH DAM ON THE YELLOWSTONE RIVER.

In the larger dams of this kind the brush is tied into bundles with galvanized-iron wire, these bundles being deposited in layers with the butts downstream and weighted with rock and boulders. A good example of this construction is shown in Plate I, figure 2. This dam has served for a score or more of years to divert water from the Yellowstone River into the Big Ditch, which irrigates about 25,000 acres of land near Billings, Mont. Figure 1 is a view of the same dam when it was undergoing repairs.

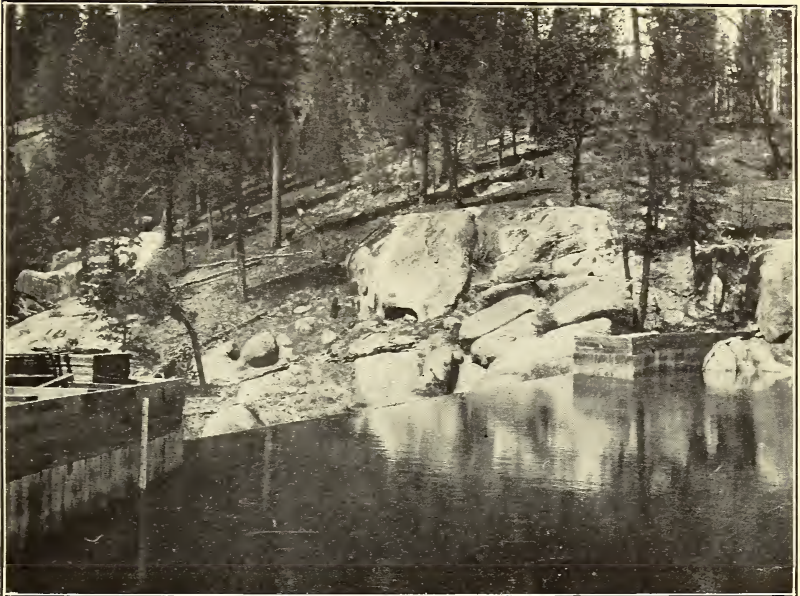
heavy grade of roofing paper to increase the imperviousness. At both ends of the dam bulkheads consisting of cribbing were built up about 7 feet above the crest of the dam and well anchored to the bedrock. These bulkheads were then faced with planking and filled with loose rock, adding to the stability. (Pl. V, fig. 1.)

FIG. 1.—BULKHEADS AND CREST OF SPILLWAY, FROM UPSTREAM SIDE, LYONS DAM, CAL.

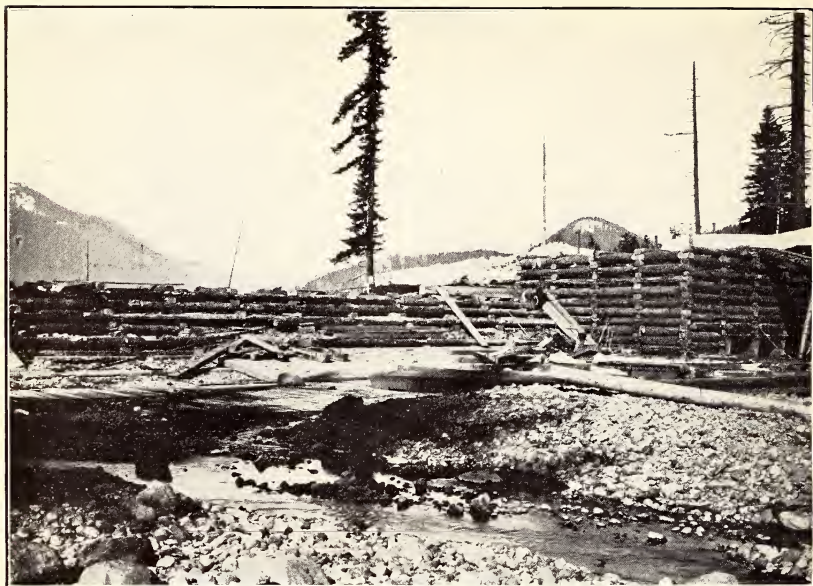
and a clay and gravel embankment with a slope of 2 to 1 was placed on the upstream side of the cribbing. The surface of this embankment was then paved with hand-placed riprap. The cribbing on the downstream side (Pl. VI, fig. 1) was constructed so that the logs were on a  $1\frac{1}{2}$  to 1 slope for the upper 12 feet (horizontal measurement), and then a slope of 6 to 1 for the next 12 feet. The latter slope breaks onto the apron, which is 24 feet wide. The apron and spillway were covered with 6-inch hewed timbers with  $1\frac{1}{2}$ -inch open joints and secured to the logs at every intersection with two  $\frac{5}{8}$  by 13 inch drift bolts. (Fig. 12.) All holes for drift bolts were bored  $\frac{1}{8}$  inch smaller than the diameter of the bolt. To bring the channel up flush with the apron a rock fill with a slope of 15 to 1 was placed at the toe of the apron and consisted of hand-placed riprap.

FIG. 1.—LAKE KEECHELUS CRIB DAM DURING CONSTRUCTION, DOWNSTREAM VIEW.

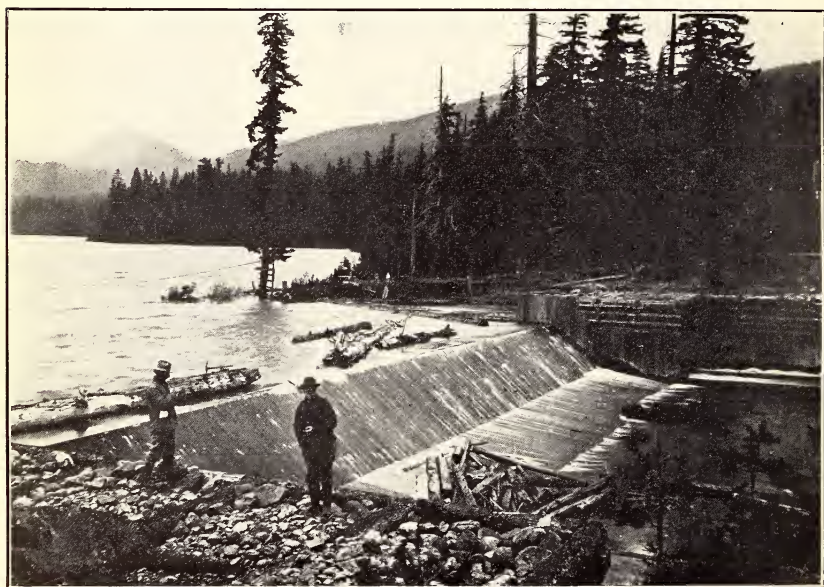
2-inch planks, tongue and groove, and had an average penetration in the soil of 9 feet. The completed dam is seen in Plate VI, figure 2, showing the bulkhead with the sheathing partially finished. The location of the outlet is indicated in the picture by two white streaks, caused by the outrushing water. It is also shown in figure 12. The conduits are roofed over by hewed timber laid transversely across partitions and sides, the minimum thickness of these timbers being 8 inches.

FIG. 2.—THE COMPLETED DAM, LAKE KEECHELUS, WASH., SHOWING SPILLWAY AND BULKHEAD.

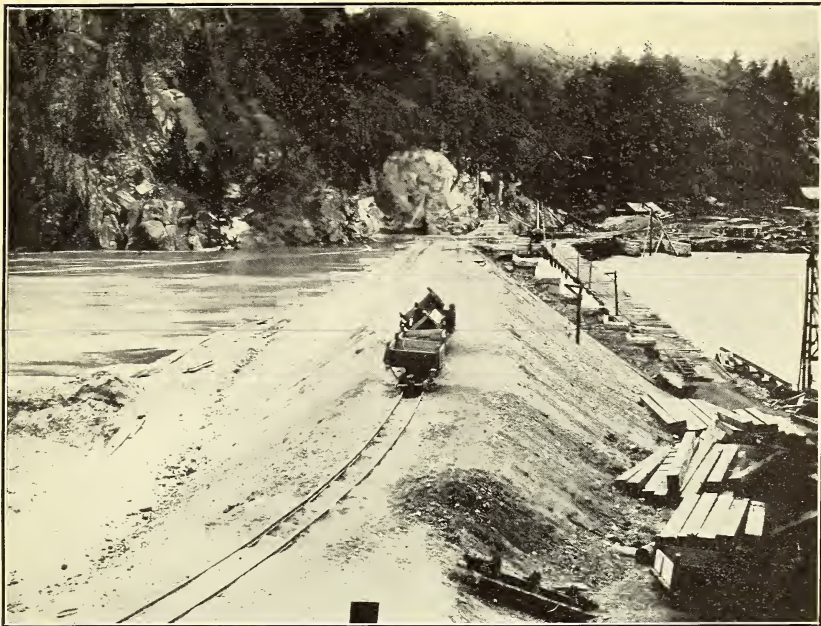
FIG. 1.—METHOD OF CONSTRUCTING EARTH FILL AT END OF CRIB DAM, CANYON FERRY DAM, MONT.

height of  $12\frac{1}{2}$  feet above its crest or flow line. On the east bank an earthen dam 285 feet long with a masonry core wall and slopes of 2 to 1 and  $1\frac{1}{2}$  to 1, respectively, on the upstream and downstream sides, was built to the hillsides. (Pl. VII, fig. 1.) The top of the dam is at the level of the top of the abutments.

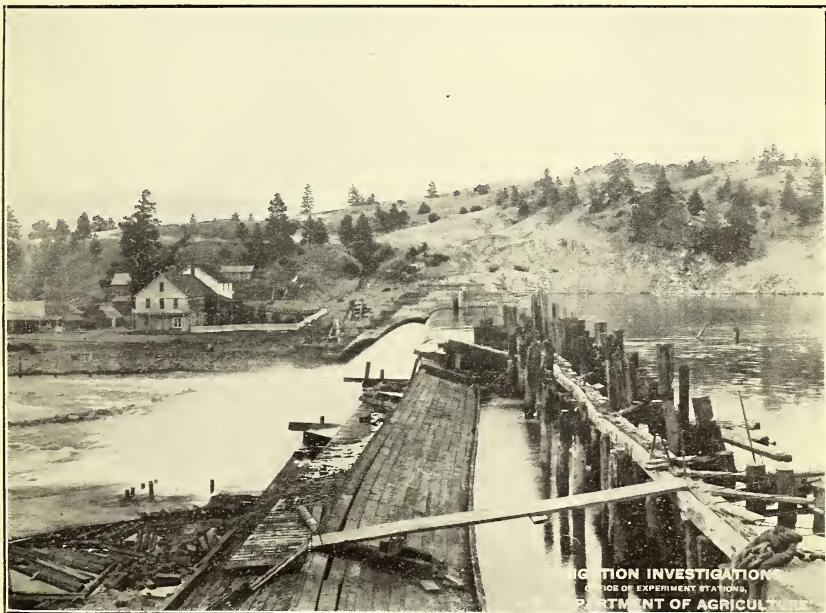
FIG. 2.—CANYON FERRY DAM, BEFORE RECONSTRUCTION.

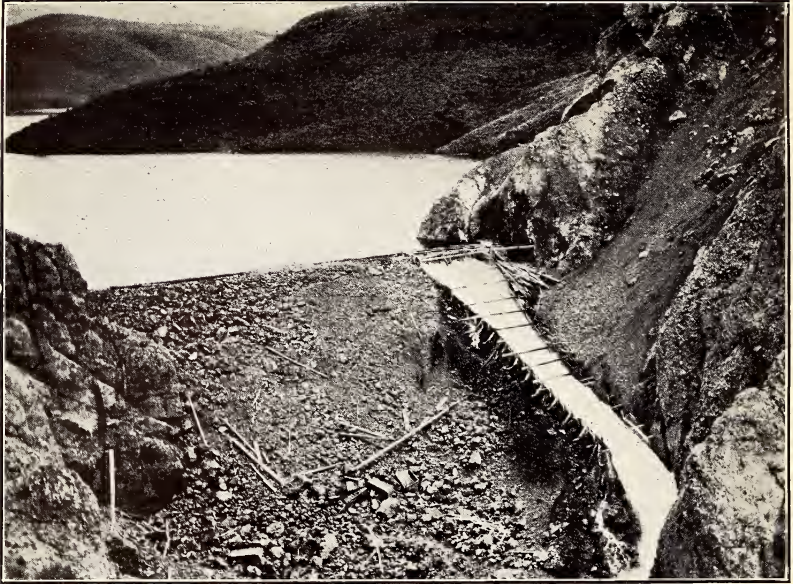
FIG. 1.—EAST CANYON DAM, UTAH, SHOWING TEMPORARY SPILLWAY.

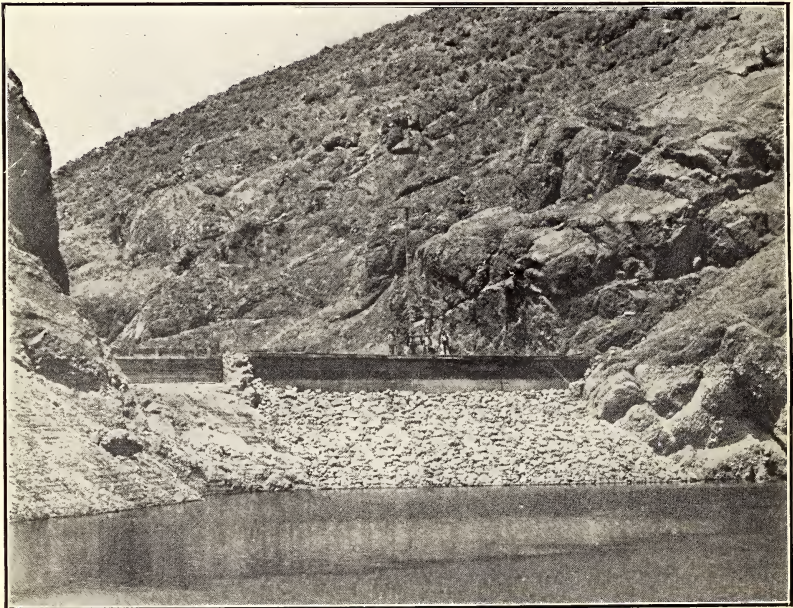
FIG. 2.—SAME, SHOWING STEEL CORE PROJECTING, AND SPILLWAY ON LEFT, AUGUST, 1900.

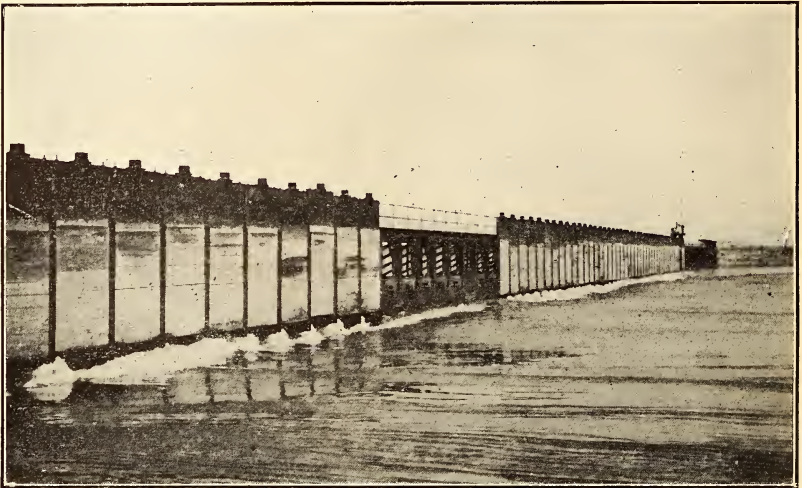
FIG. 29.—Gates in Milner Dam, Snake River, Idaho. At times of high water these gates are raised to regulate flow in canals.

Before building the north or main-channel dam it was planned to cut a tunnel through the point of the south island of sufficient size to carry the low-water flow during construction. This tunnel consisted of eight sections, each 5 feet wide and 9 feet high. The flow of water was controlled by heavy cast-steel gates, raised by geared stands. (Figs. 29, 30.) Quoting from Schuyler's work, already referred to:

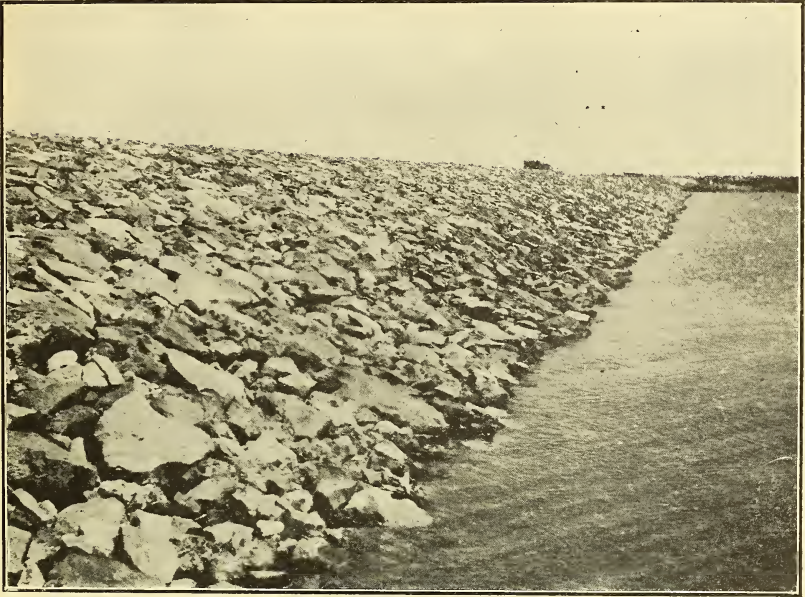
FIG. 33.—Riprapped slope, Minidoka Dam, Snake River, Idaho:

The main dam is of the loose-rock-fill type, with a concrete core back filled on the upstream slope with earth and gravel. This slope has a heavy gravel face protected by cyclopean riprap (fig. 33).

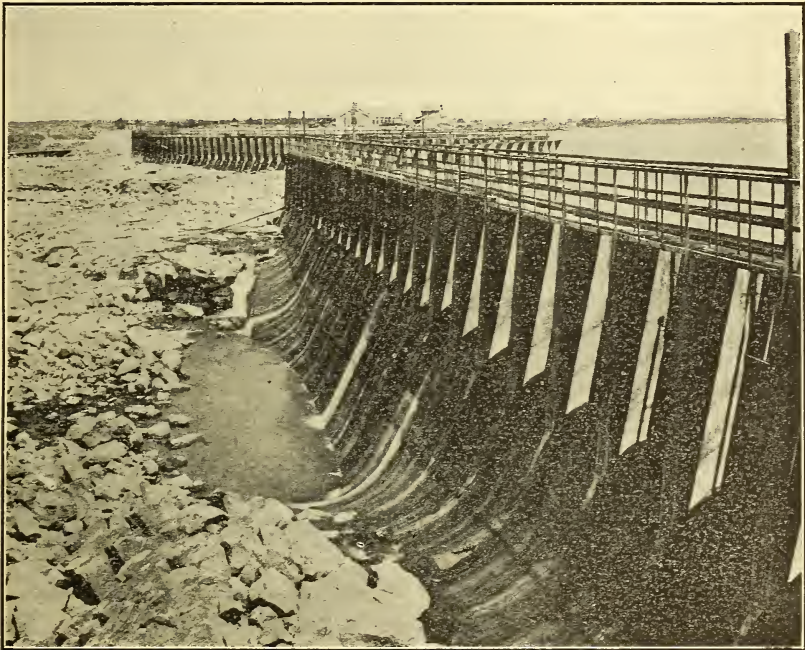
FIG. 36.—Spillway, Minidoka Dam, Idaho (U. S. Reclamation Service).

spillway (fig. 36), 2,385 feet long, was built at the south end of the dam, following the highest ridges of rock. The excavation for the
